## DRAINAGE PROBLEMS - PORTLAND PLANT

## ASH GROVE CEMENT COMPANY

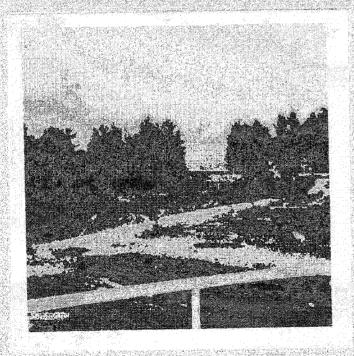
MATERIAL WE HAVE DUMPED INTO RIVER AT WEST PROPERTY LINE
